## MEMORANDUM

**To:** Caitlin Munson, Dudek  
**From:** Audrey Herschberger, Stephanie Chao, Dudek  
**Subject:** Hazardous Materials Assessment for Santee Community Center  
**Date:** April 17, 2025  
**Attachments:** A – Figure 1, Project Location  
B - Historic Aerial Photographs

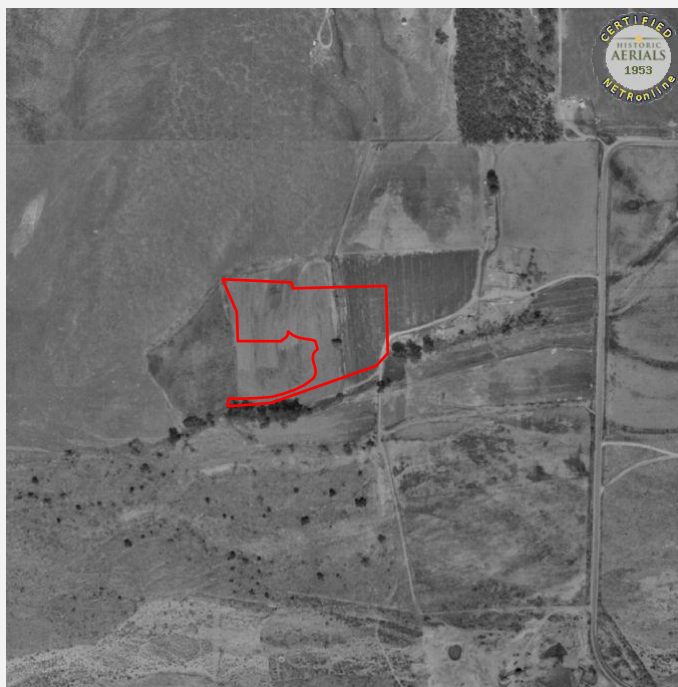
**Aerial 1.** Aerial photograph of the project site from 1953.

Date	Description
1953	The project site is vacant with an unimproved road that runs to the south and east of the project site. The surface area of the project site appears to have been mowed for potential agricultural use. The areas directly adjoining the project site appear similar to the project site while the surrounding areas of the project site appear to be vacant and undeveloped.
1966	The project site appears to have less definitive mowing or cultivation lines observed and appears similar to unused vacant land. Apparent commercial and residential structures are observed in the surrounding area, approximately 0.25 miles north, northeast, west, and southeast of the project site.
1978	The project site appears similar to the 1966 aerial photograph. Increased development has occurred in the surrounding areas.
1985	The project site appears similar to the 1978 aerial photograph. A small structure is observed just south of the project site. Further development has occurred in the surrounding areas.

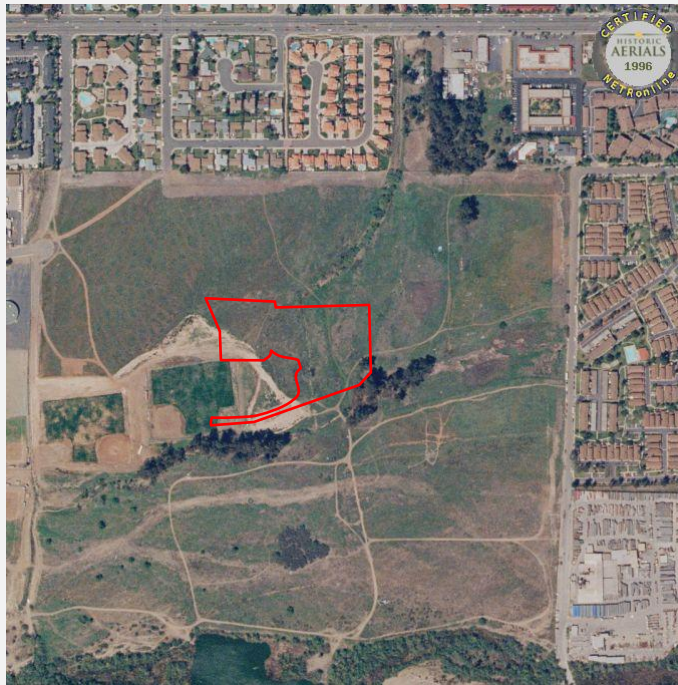
**Aerial 5.** Aerial photograph of the project site from 1996.

1996	The project site appears similar to the 1985 aerial photograph. The small structure previously observed south of the project site in the 1985 aerial photograph is no longer present. The area adjoining to the southwest of the project site appears to be undergoing development where previous vegetation has been cleared. Increased development is observed in the surrounding areas north and southeast of the project site.

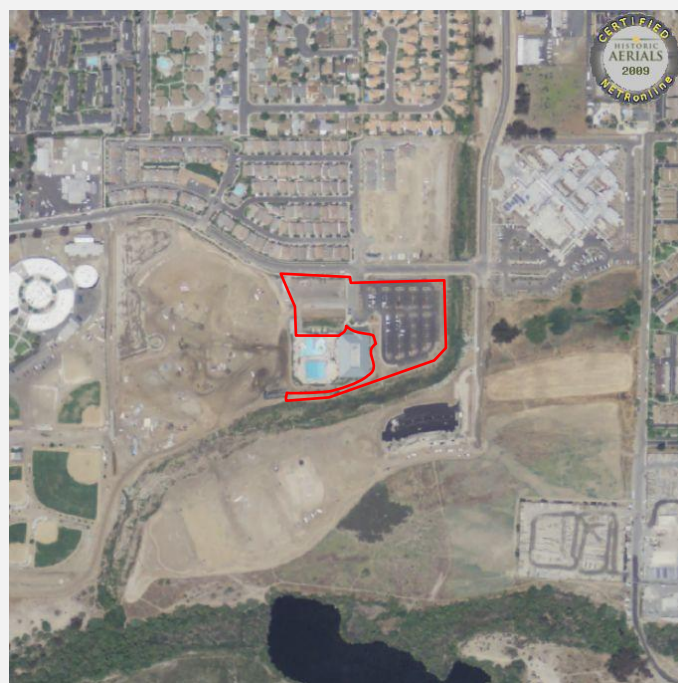
**Aerial 8.** Aerial photograph of the project site from 2009.

2009	The project site now appears to be entirely developed as a parking lot for the southwestern adjoining recreational facility. More area appears to be under construction farther to the west. Increased vegetation adjoining to the east and south around a channelized tributary is observed. A road has been constructed to the north (Riverwalk Drive) leading to the recreational facility, and another development to the northeast (nursing facility) is observed. Increased residential development is observed north of the project site with increased recreational development observed west and south of the project site.
2014	The western portion of the project site is now a grass field, while the eastern portion remains a parking lot. The recreational facility adjoining to the west is complete with baseball diamonds and additional buildings. Increased residential development is observed north of the project site with increased recreational development observed west and south of the project site.
