# **GEOTECHNICAL INVESTIGATION**

## **FANITA RANCH FANITA PARKWAY WIDENING AND EXTENSION STATION 9+35 TO 111+50 SANTEE, CALIFORNIA**

**APRIL 17, 2020  
PROJECT NO. 05254-32-18A**

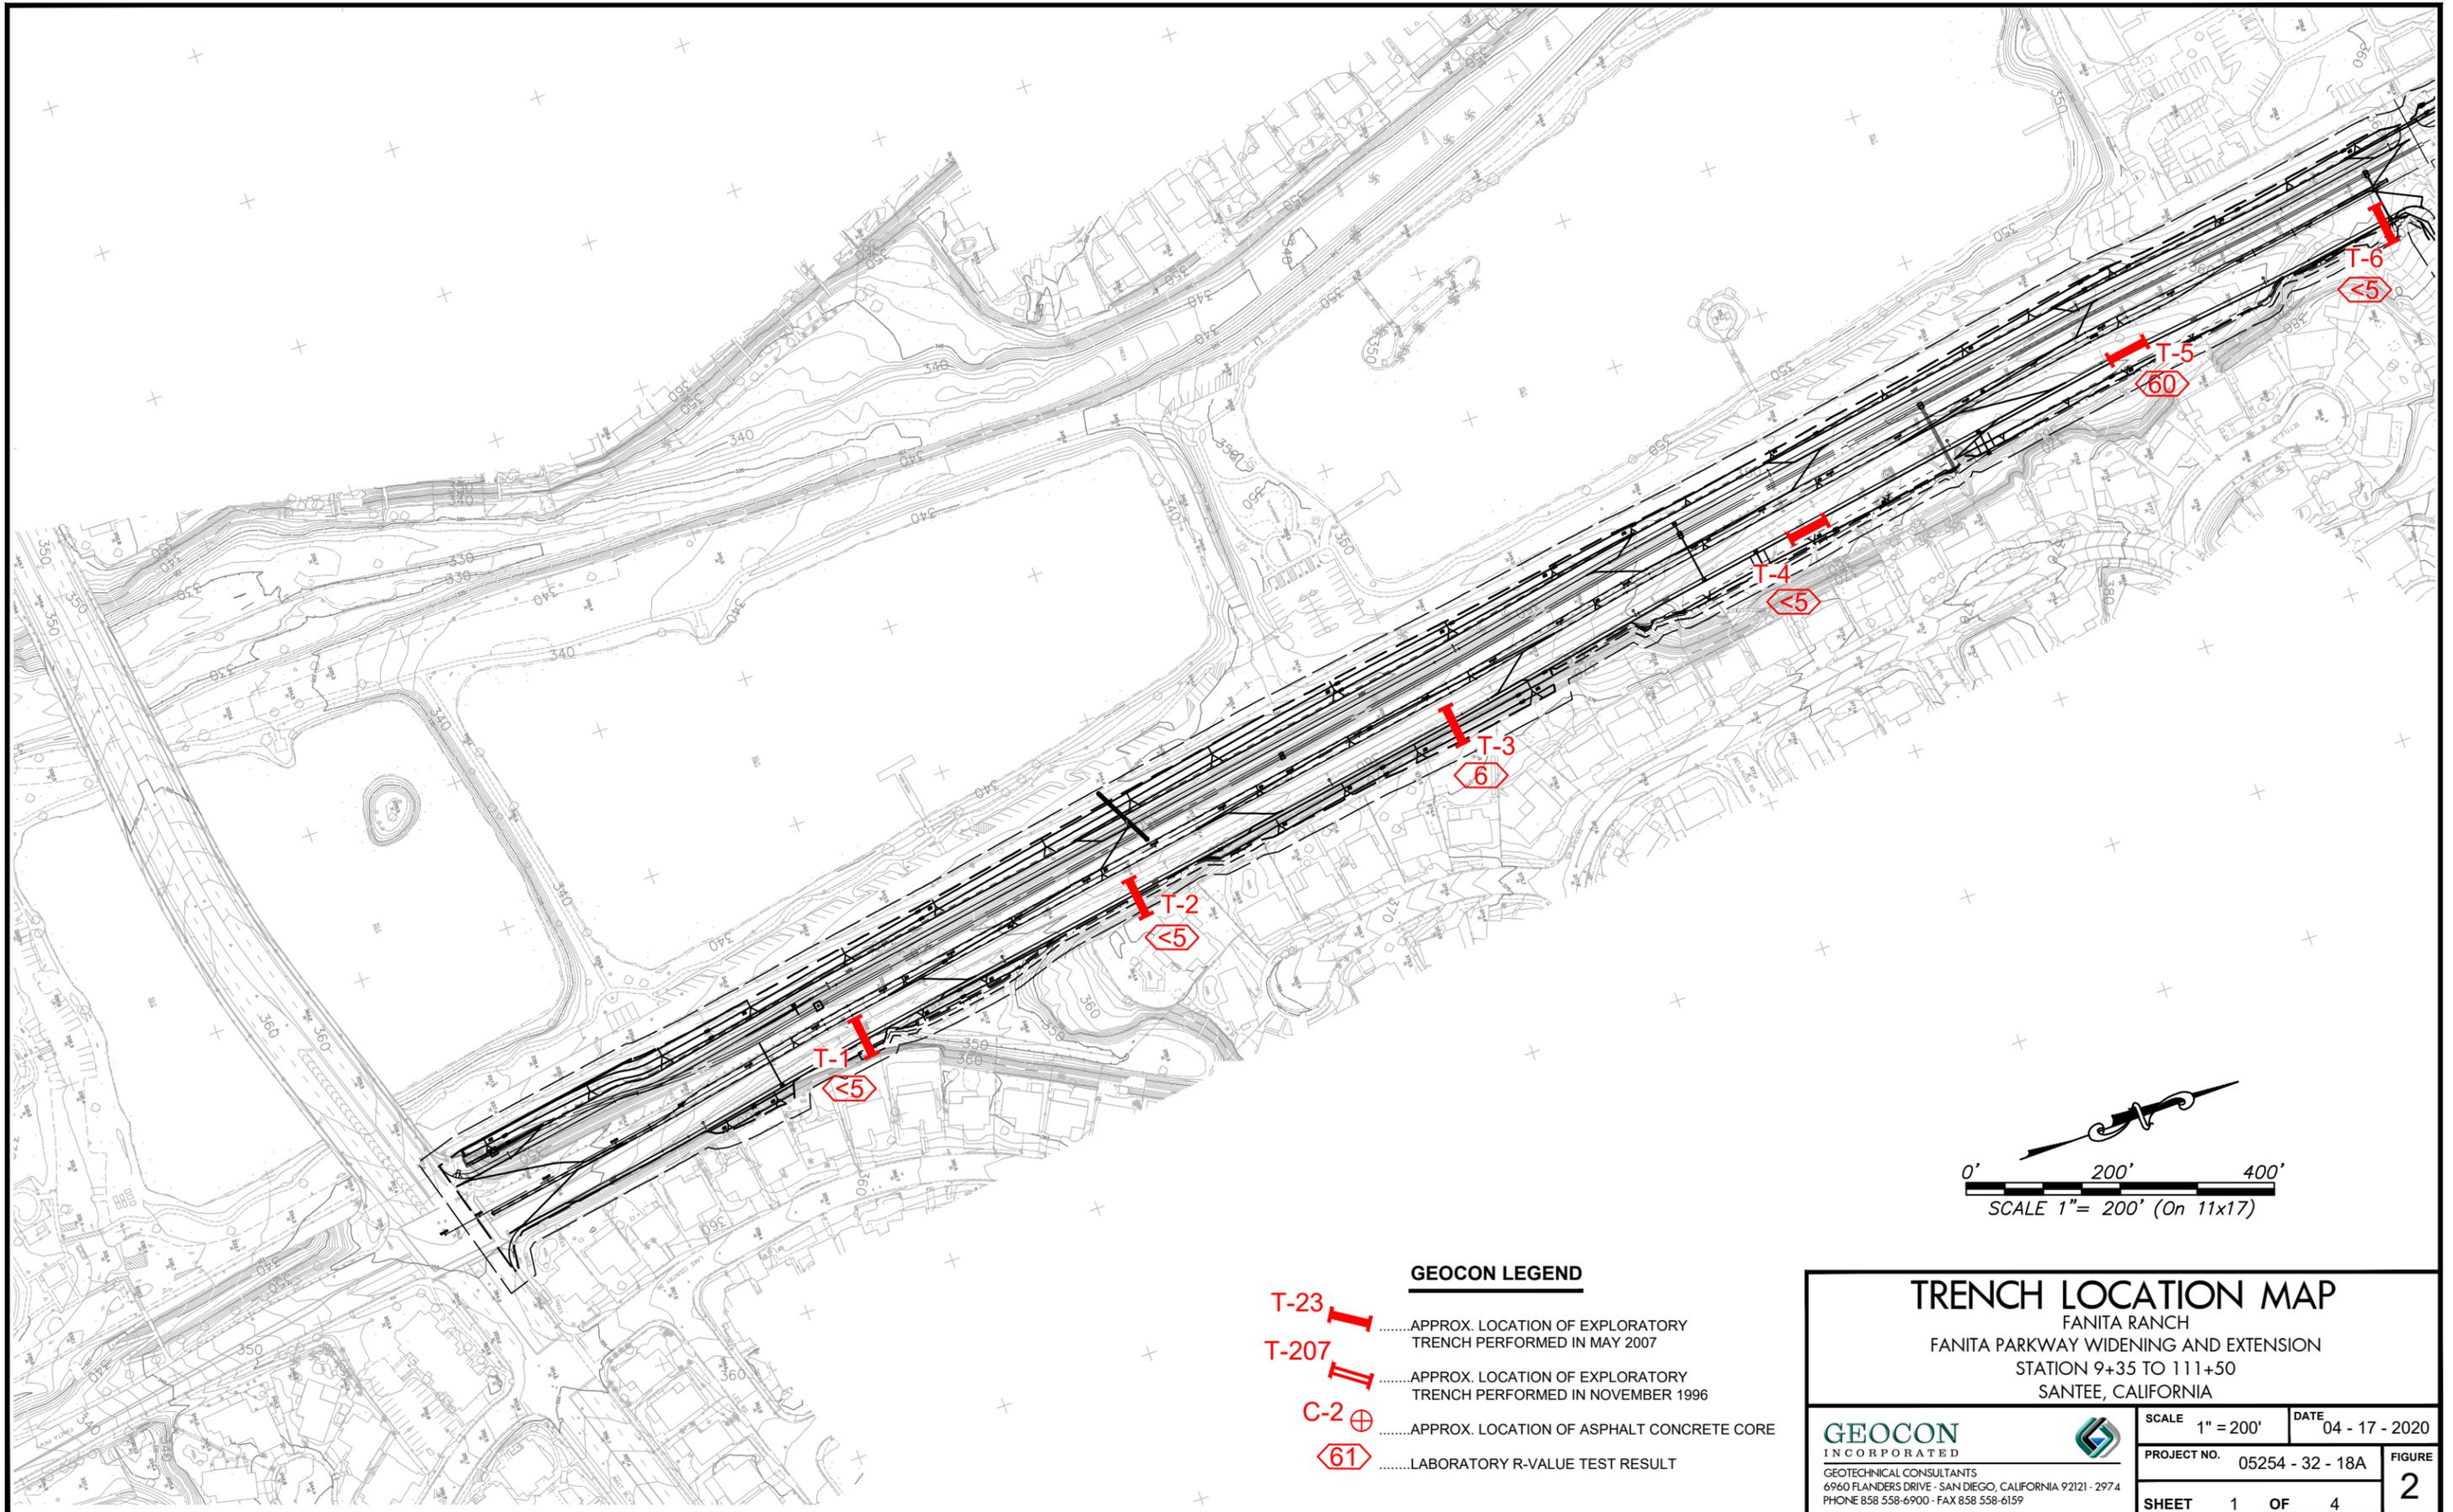
SCALE 1" = 200'	DATE 04 - 17 - 2020
PROJECT NO. 05254 - 32 - 18A	FIGURE 2
SHEET 1 OF 4

- T-23 ..... APPROX. LOCATION OF EXPLORATORY TRENCH PERFORMED IN MAY 2007
- T-207 ..... APPROX. LOCATION OF EXPLORATORY TRENCH PERFORMED IN NOVEMBER 1996
- C-2 ..... APPROX. LOCATION OF ASPHALT CONCRETE CORE
- ..... LABORATORY R-VALUE TEST RESULT

Details of the field investigation as well as a description of the trench logs are presented in Appendix A and a summary of the laboratory test results are presented in Appendix B. Figures 2 through 5 (*Trench Location Map*) depict the approximate locations of each exploratory trench location. The base map used to depict the trench locations consisted of AutoCAD files of the proposed improvements entitled *Fanita Ranch – Vesting Tentative Map/Preliminary Grading Plan*, Sheets 25 through 32, prepared by Hunsaker & Associates San Diego, Inc., Revision 5 dated March 27, 2020.

The original field investigation for Fanita Parkway was performed on May 7 and 8, 2007, and consisted of a site reconnaissance and the excavation of 23 exploratory trenches. The approximate locations of the trenches are shown on the *Trench Location Map*, Figures 2 through 5.

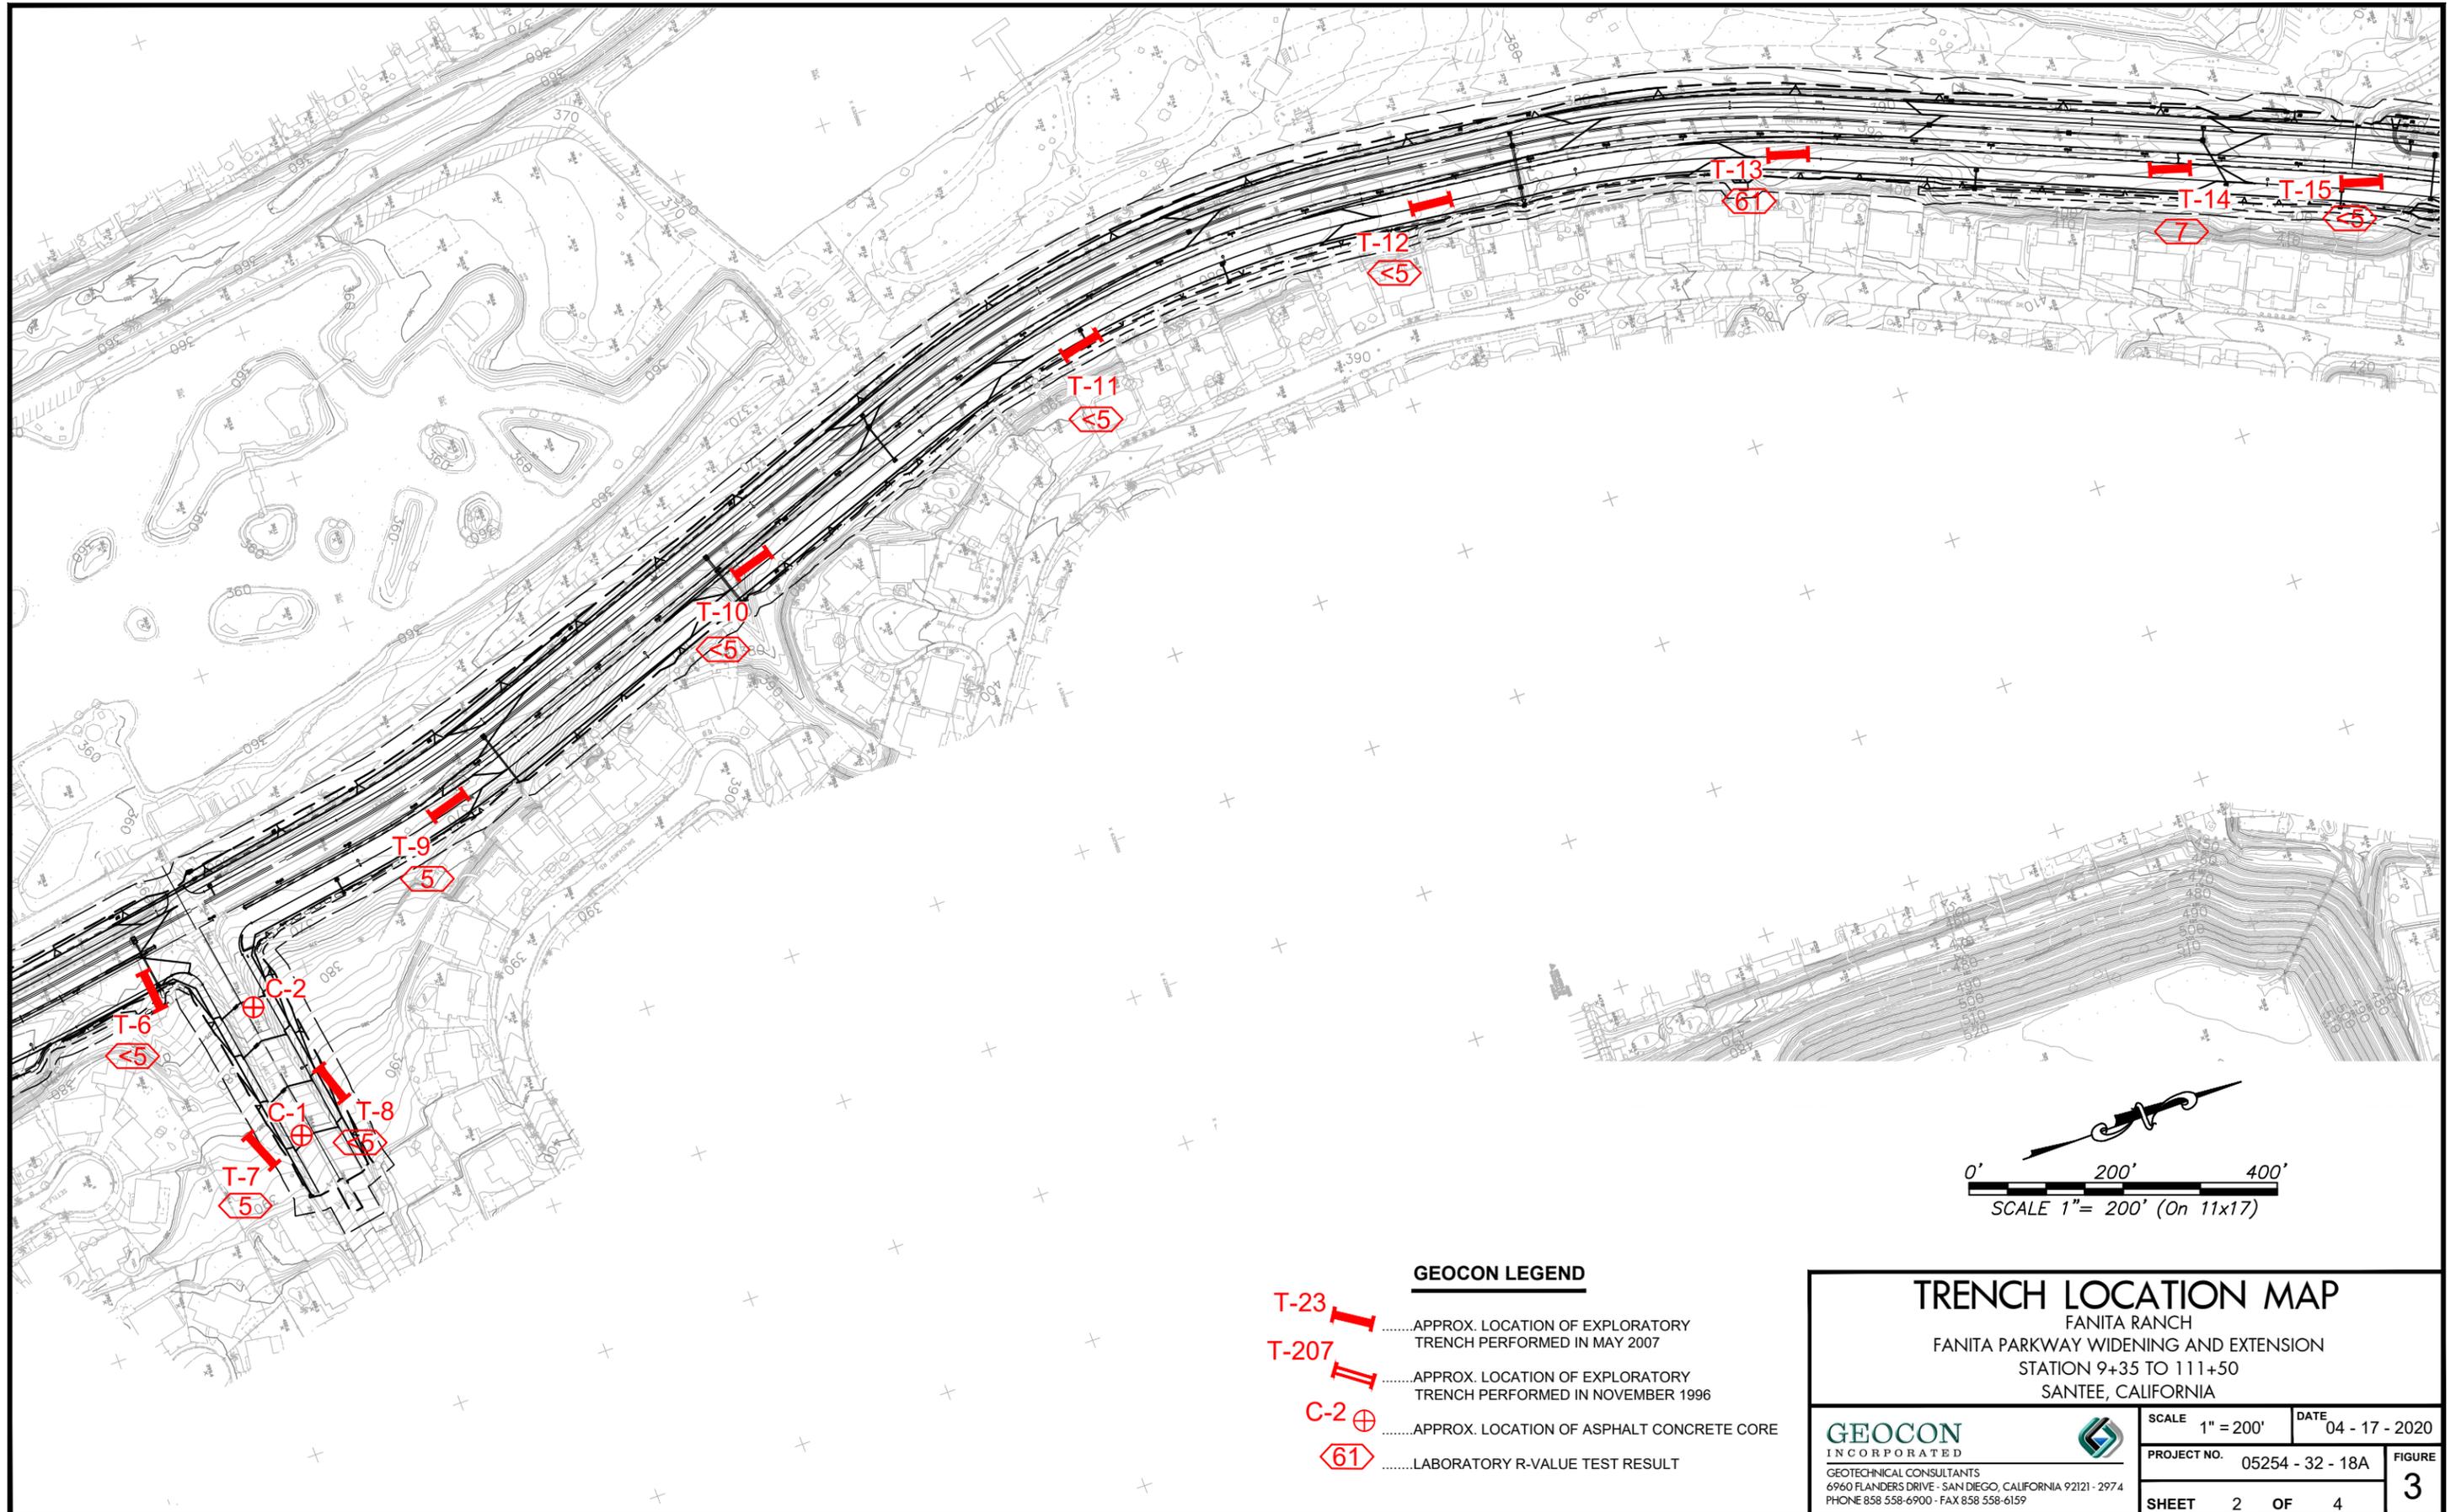
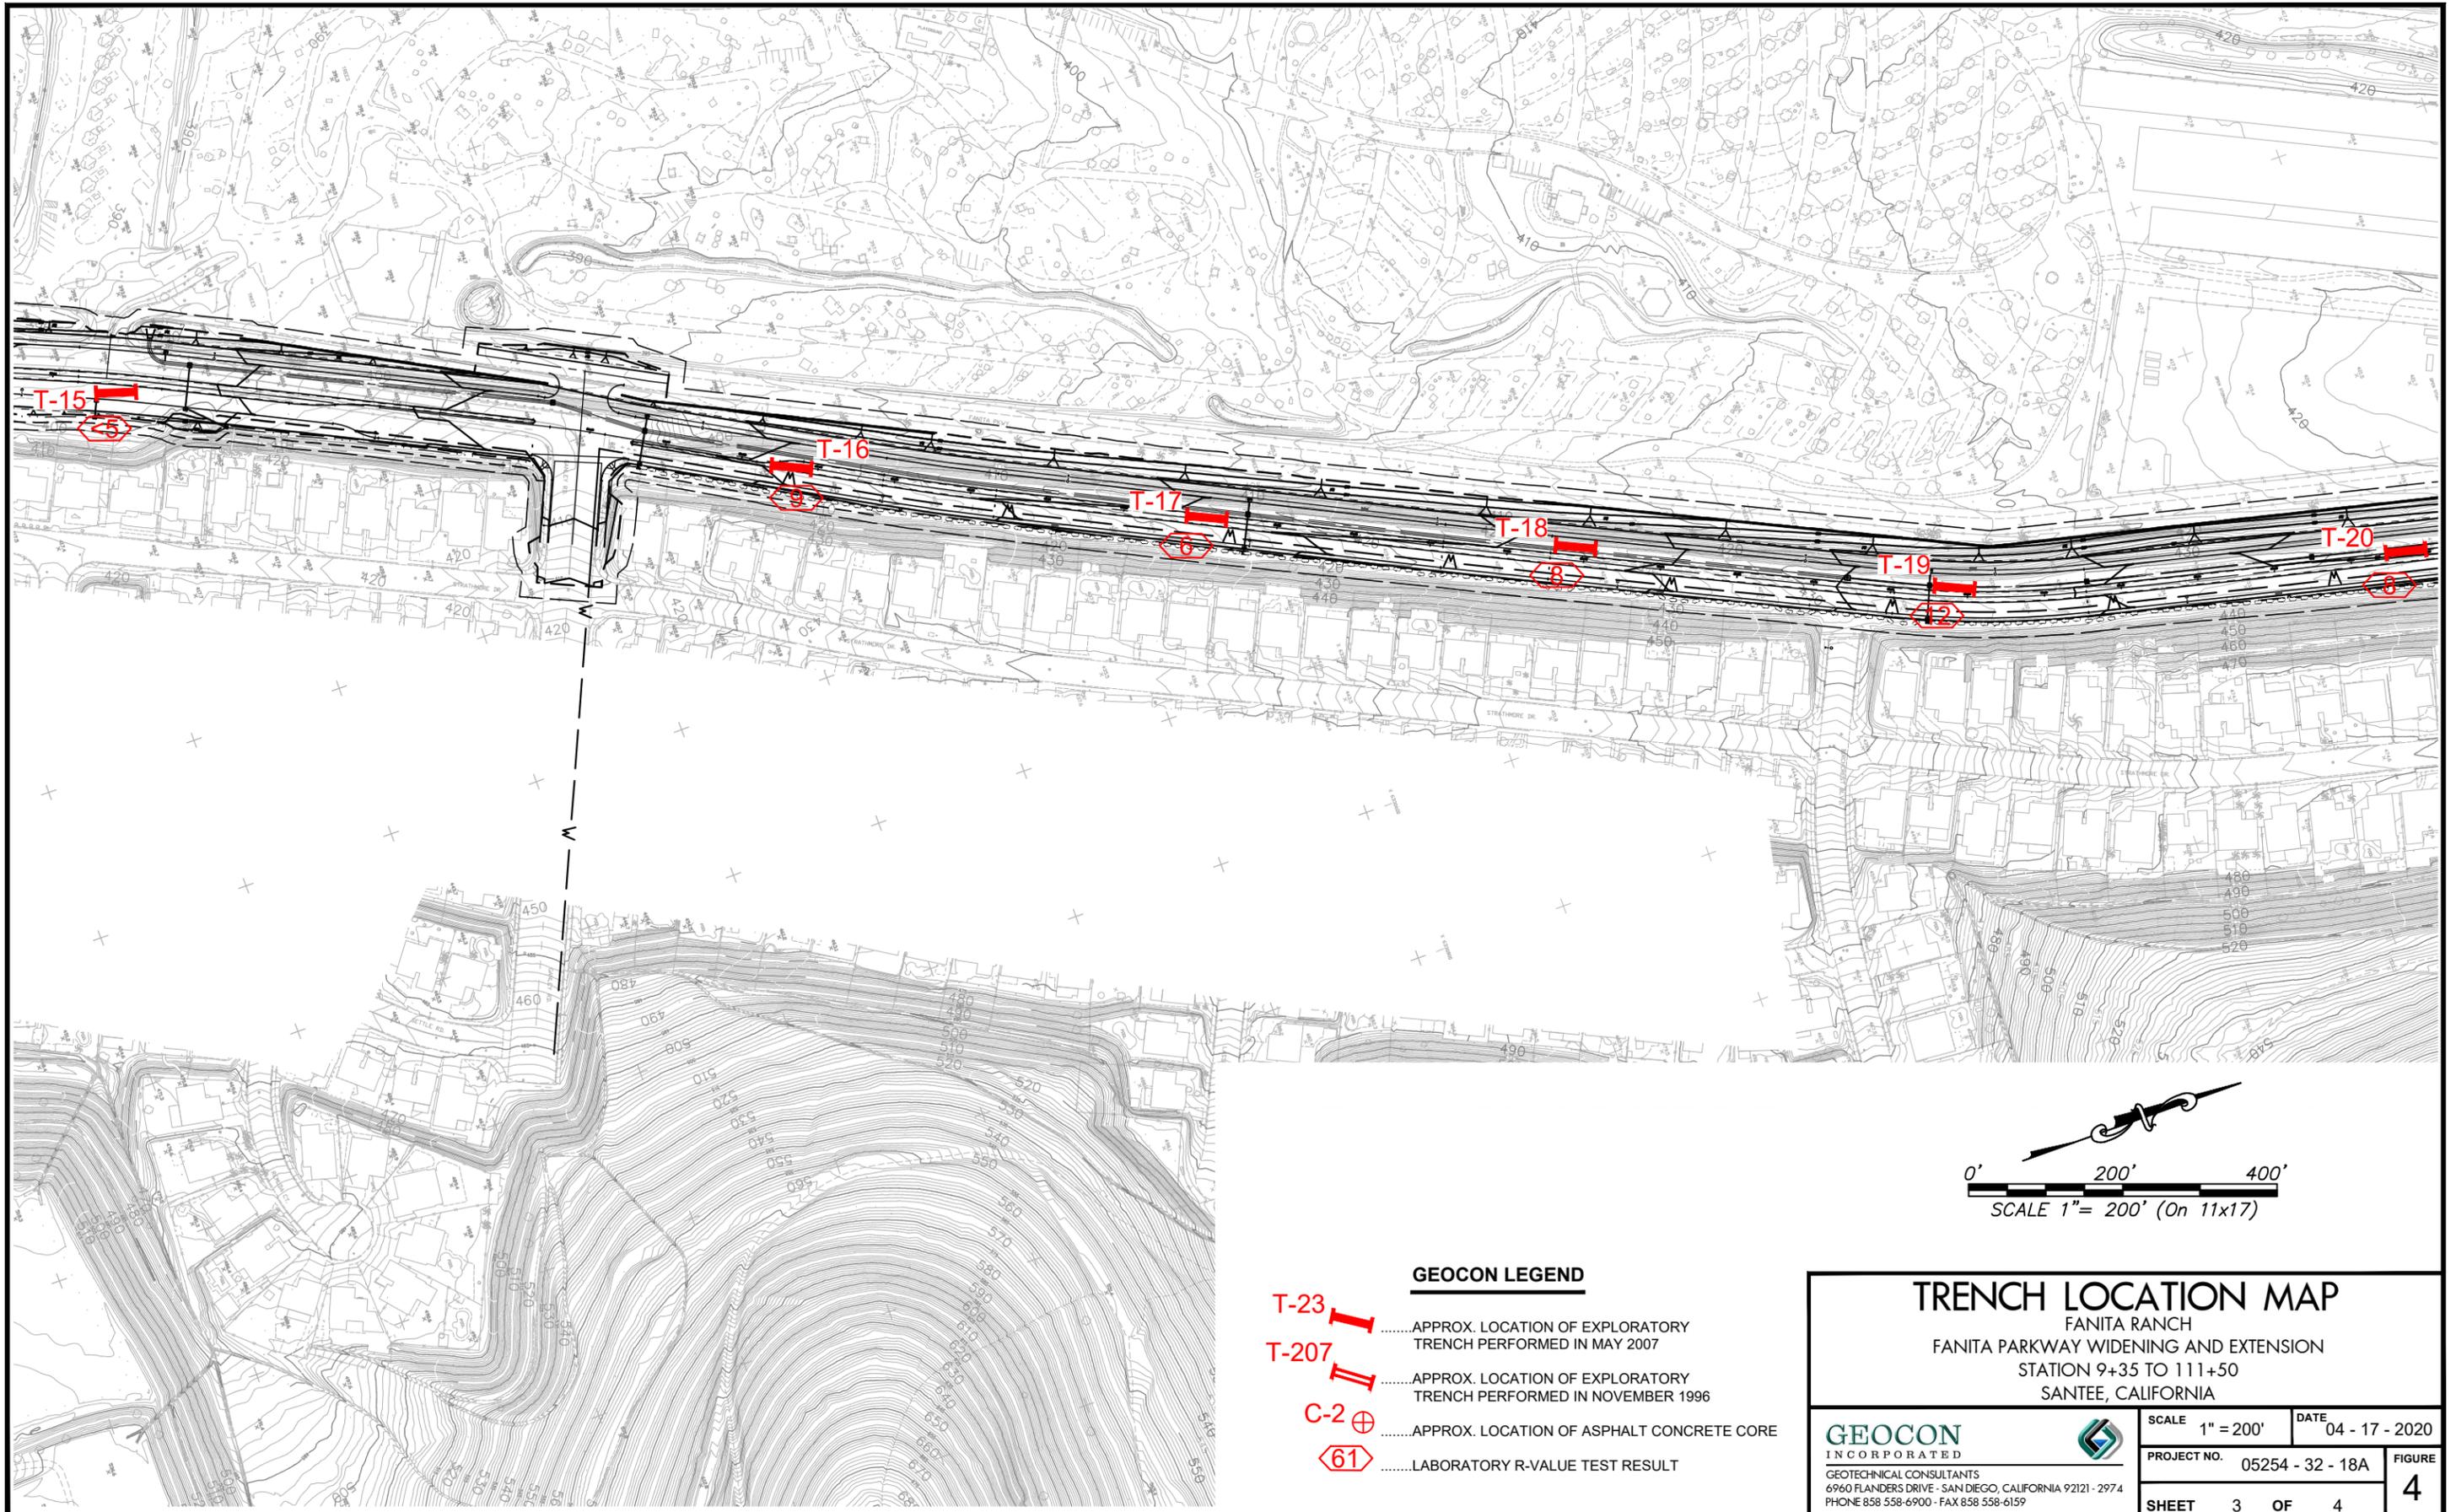
- GEOCON LEGEND**
- T-23 ..... APPROX. LOCATION OF EXPLORATORY TRENCH PERFORMED IN MAY 2007
  - T-207 ..... APPROX. LOCATION OF EXPLORATORY TRENCH PERFORMED IN NOVEMBER 1996
  - C-2 ..... APPROX. LOCATION OF ASPHALT CONCRETE CORE
  - 61 ..... LABORATORY R-VALUE TEST RESULT

<b>TRENCH LOCATION MAP</b>								
FANITA RANCH FANITA PARKWAY WIDENING AND EXTENSION STATION 9+35 TO 111+50 SANTEE, CALIFORNIA								
<b>GEOCON</b> INCORPORATED GEOTECHNICAL CONSULTANTS 6960 FLANDERS DRIVE - SAN DIEGO, CALIFORNIA 92121 - 2974 PHONE 858 558-6900 - FAX 858 558-6159

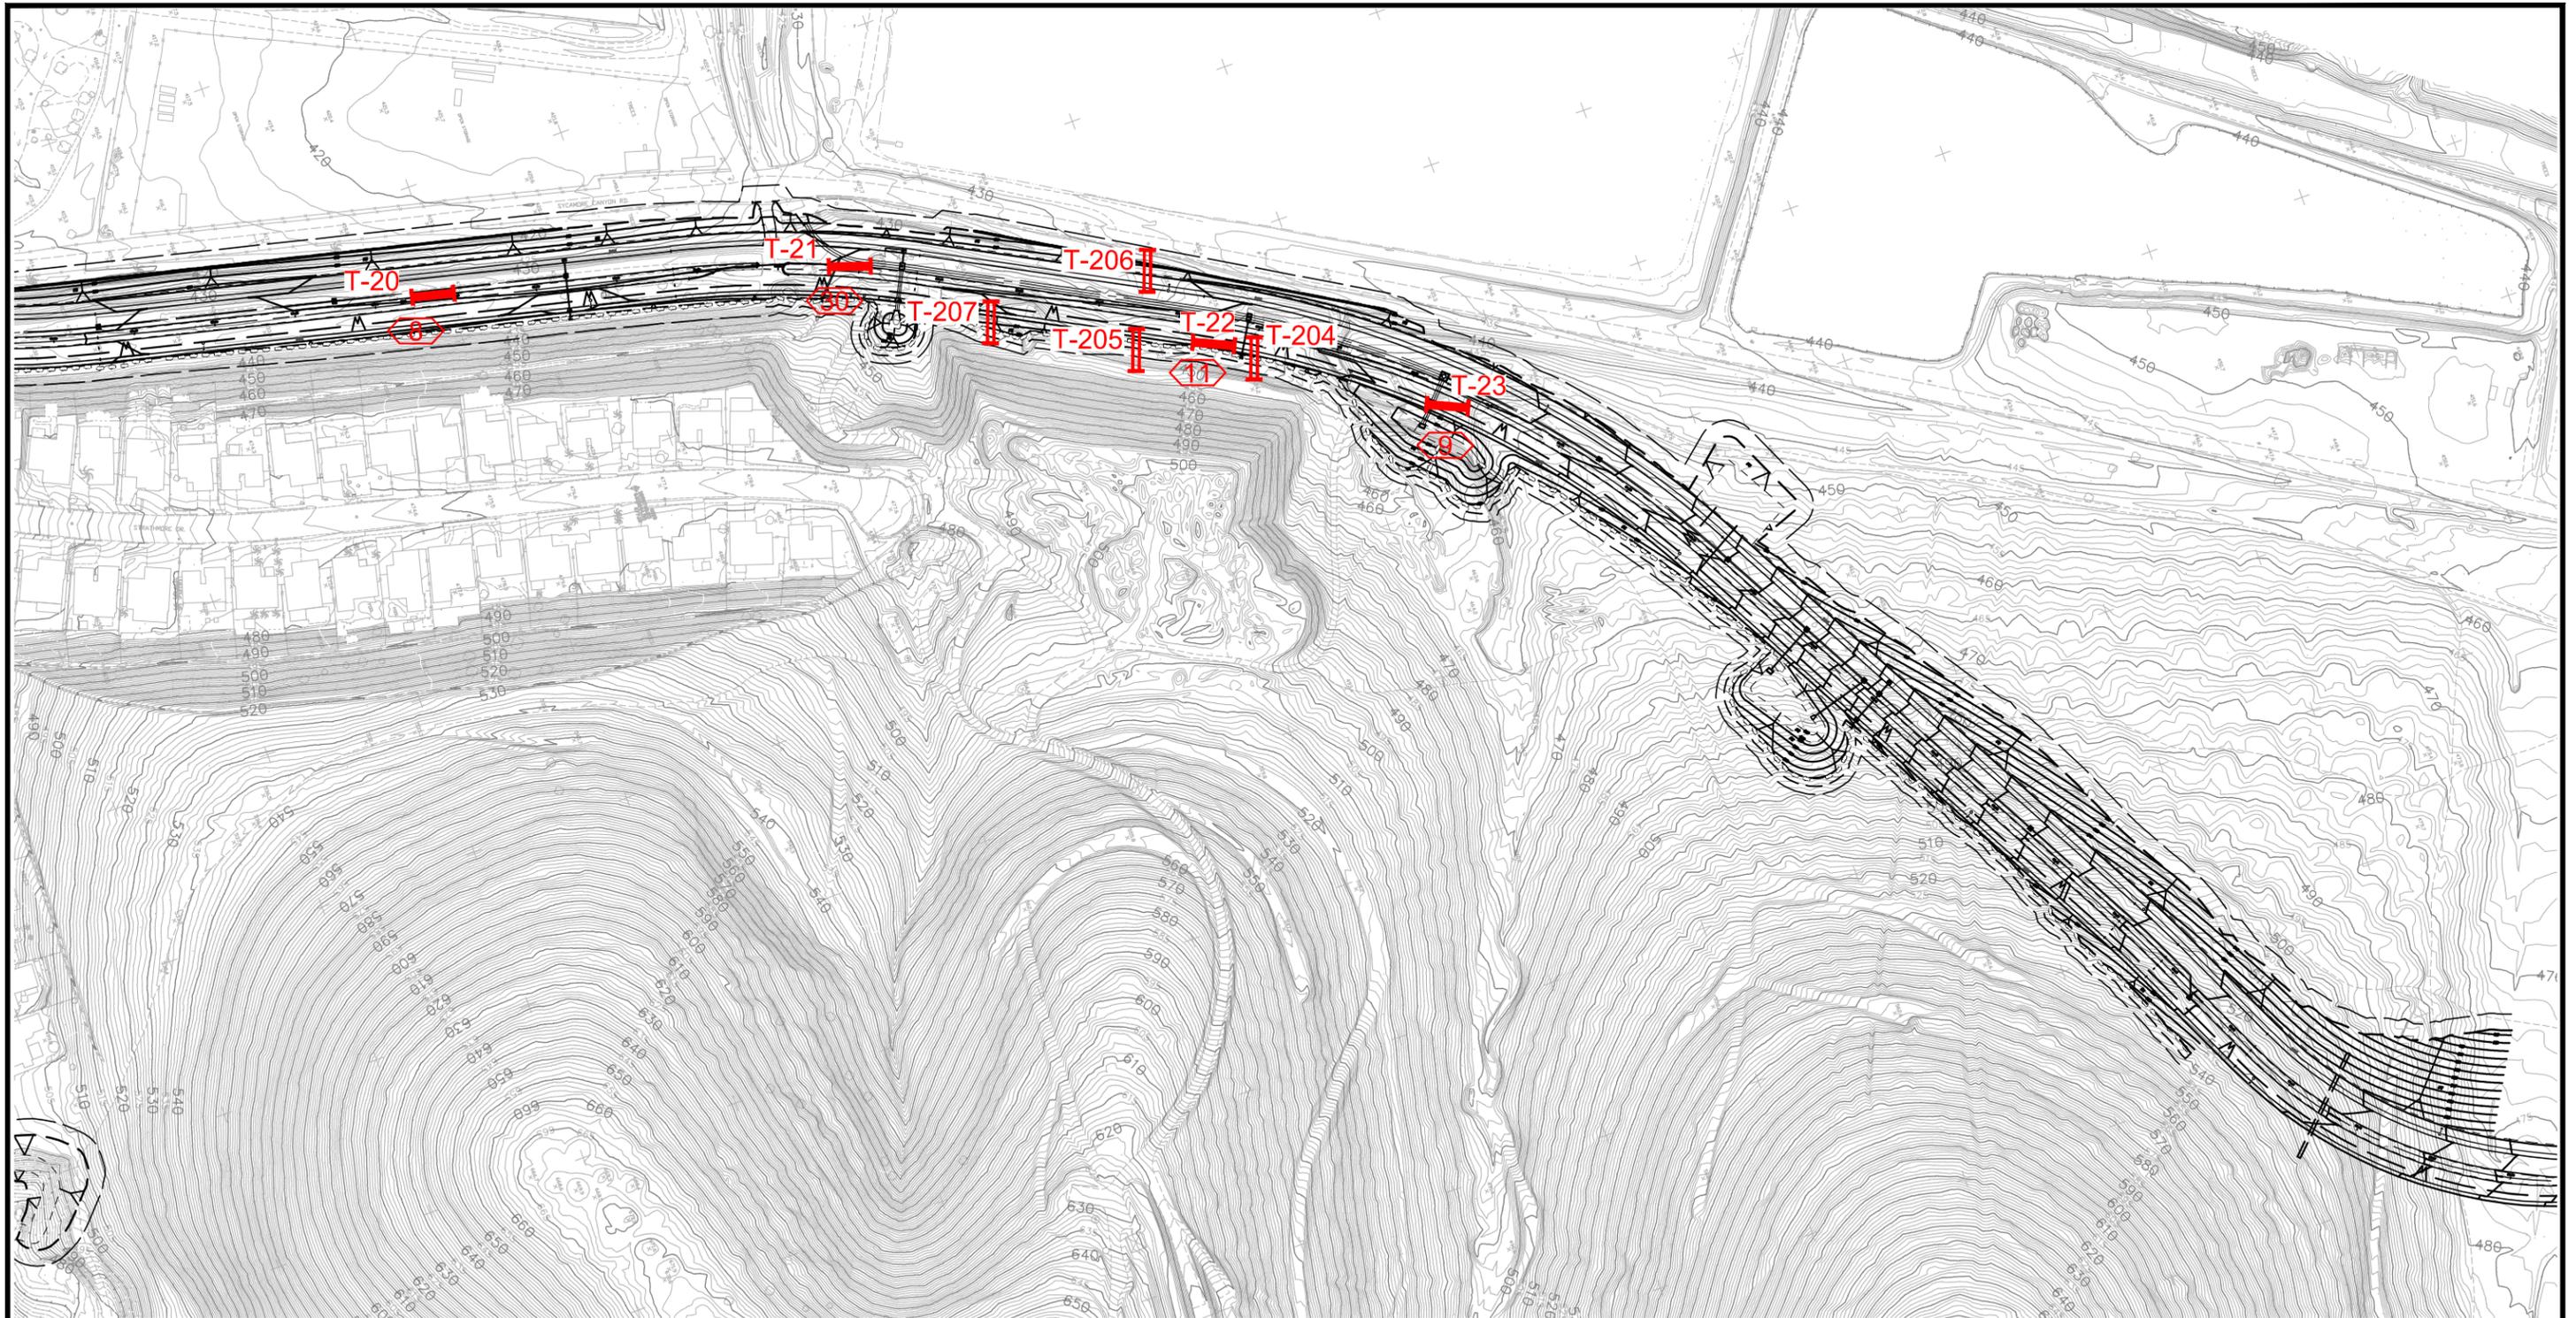
**GEOCON LEGEND**

- T-23 ..... APPROX. LOCATION OF EXPLORATORY TRENCH PERFORMED IN MAY 2007
- T-207 ..... APPROX. LOCATION OF EXPLORATORY TRENCH PERFORMED IN NOVEMBER 1996
- C-2 ..... APPROX. LOCATION OF ASPHALT CONCRETE CORE
- 61 ..... LABORATORY R-VALUE TEST RESULT

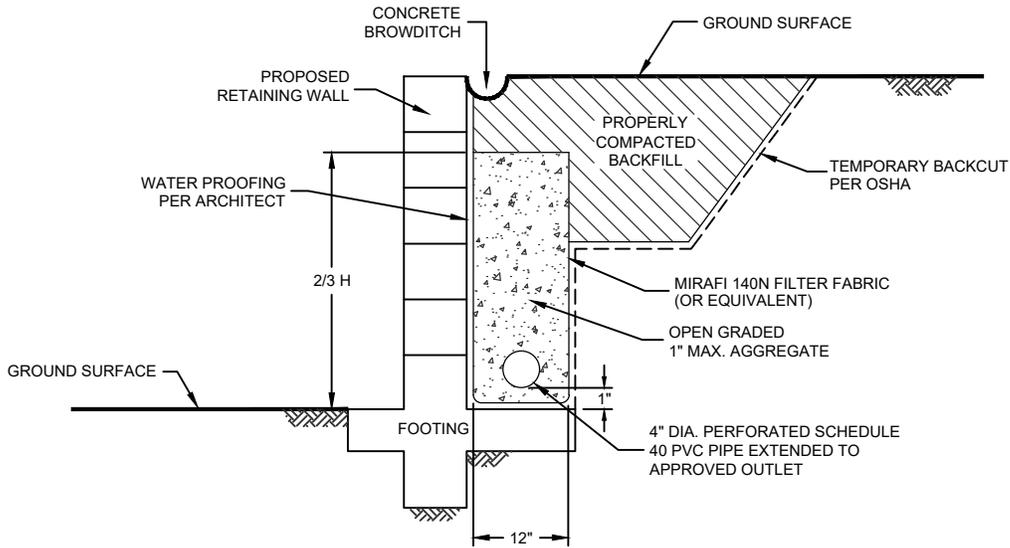
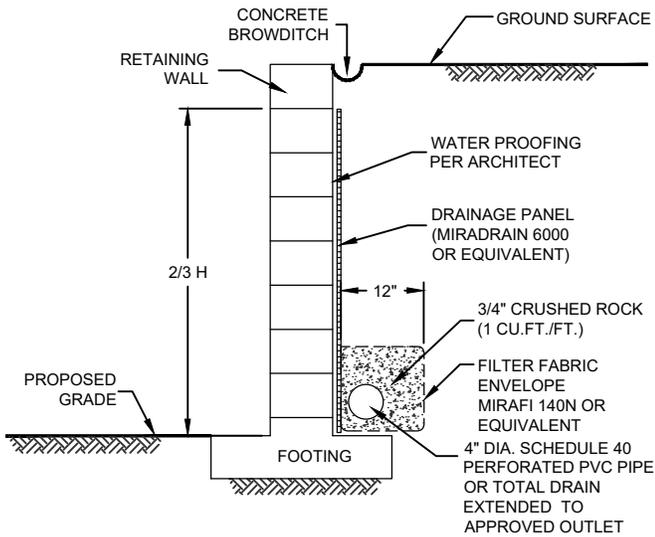
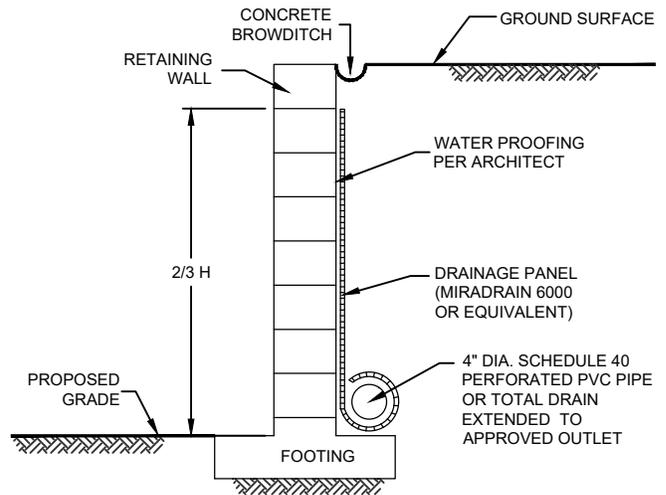
NOTE :

DRAIN SHOULD BE UNIFORMLY SLOPED TO GRAVITY OUTLET  
OR TO A SUMP WHERE WATER CAN BE REMOVED BY PUMPING

- Figure 1, Vicinity Map
- Figures 2 – 5, Trench Location Maps
- Figure 6, Fill Slope Stability Analysis – Fill Slopes
- Figure 7, Surficial Slope Stability Analysis
- Figure 8, Typical Retaining Wall Drain Detail

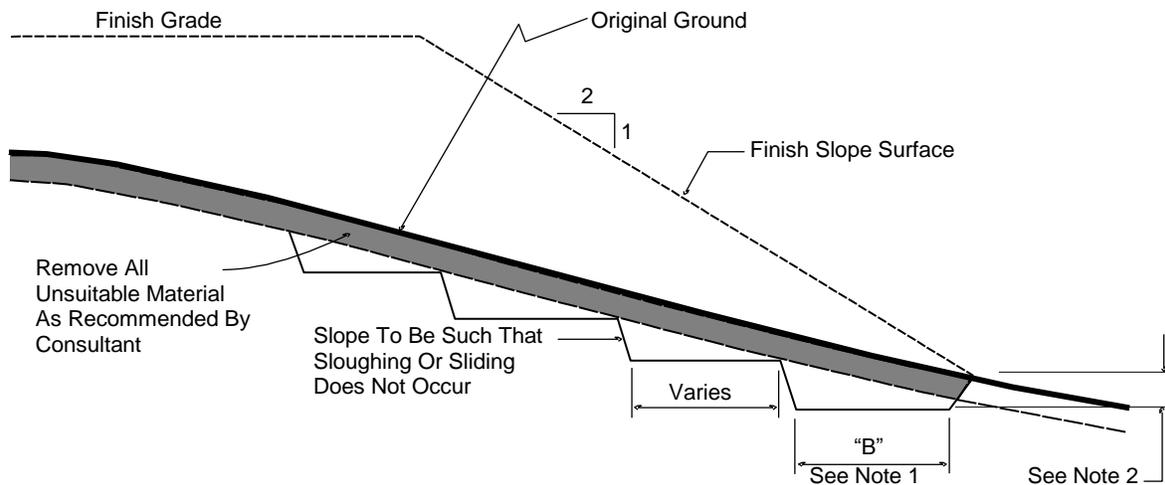
**TYPICAL BENCHING DETAIL**

- DETAIL NOTES: (1) Key width "B" should be a minimum of 10 feet, or sufficiently wide to permit complete coverage with the compaction equipment used. The base of the key should be graded horizontal, or inclined slightly into the natural slope.
- (2) The outside of the key should be below the topsoil or unsuitable surficial material and at least 2 feet into dense formational material. Where hard rock is exposed in the bottom of the key, the depth and configuration of the key may be modified as approved by the Consultant.

- 4.3 After clearing and grubbing of organic matter and other unsuitable material, loose or porous soils shall be removed to the depth recommended in the Geotechnical Report. The depth of removal and compaction should be observed and approved by a representative of the Consultant. The exposed surface shall then be plowed or scarified to a minimum depth of 6 inches and until the surface is free from uneven features that would tend to prevent uniform compaction by the equipment to be used.
- 4.4 Where the slope ratio of the original ground is steeper than 5:1 (horizontal:vertical), or where recommended by the Consultant, the original ground should be benched in accordance with the following illustration.

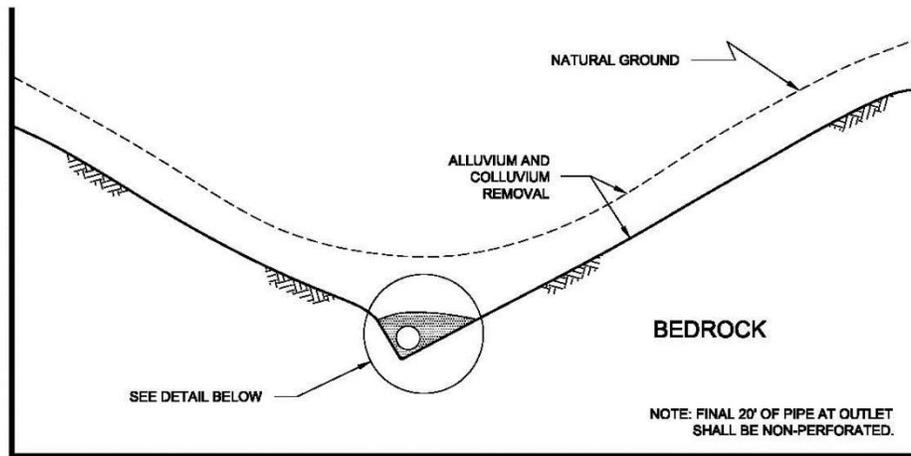
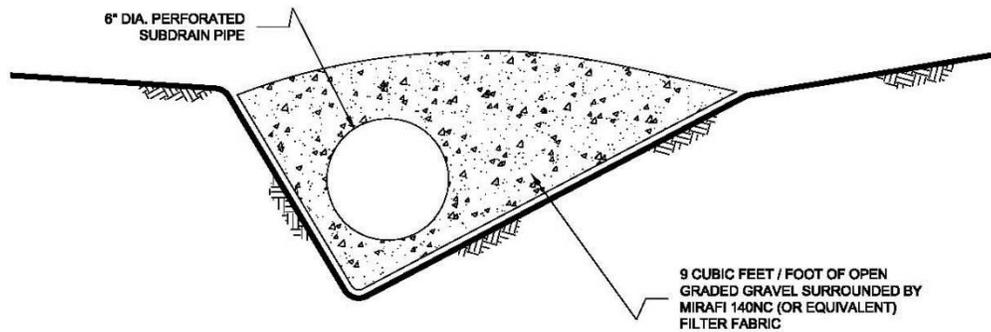
## TYPICAL CANYON DRAIN DETAIL

### NOTES:

- 1.....8-INCH DIAMETER, SCHEDULE 80 PVC PERFORATED PIPE FOR FILLS IN EXCESS OF 100-FEET IN DEPTH OR A PIPE LENGTH OF LONGER THAN 500 FEET.
- 2.....6-INCH DIAMETER, SCHEDULE 40 PVC PERFORATED PIPE FOR FILLS LESS THAN 100-FEET IN DEPTH OR A PIPE LENGTH SHORTER THAN 500 FEET.

- 7.1 The geologic units on the site may have permeability characteristics and/or fracture systems that could be susceptible under certain conditions to seepage. The use of canyon subdrains may be necessary to mitigate the potential for adverse impacts associated with seepage conditions. Canyon subdrains with lengths in excess of 500 feet or extensions of existing offsite subdrains should use 8-inch-diameter pipes. Canyon subdrains less than 500 feet in length should use 6-inch-diameter pipes.

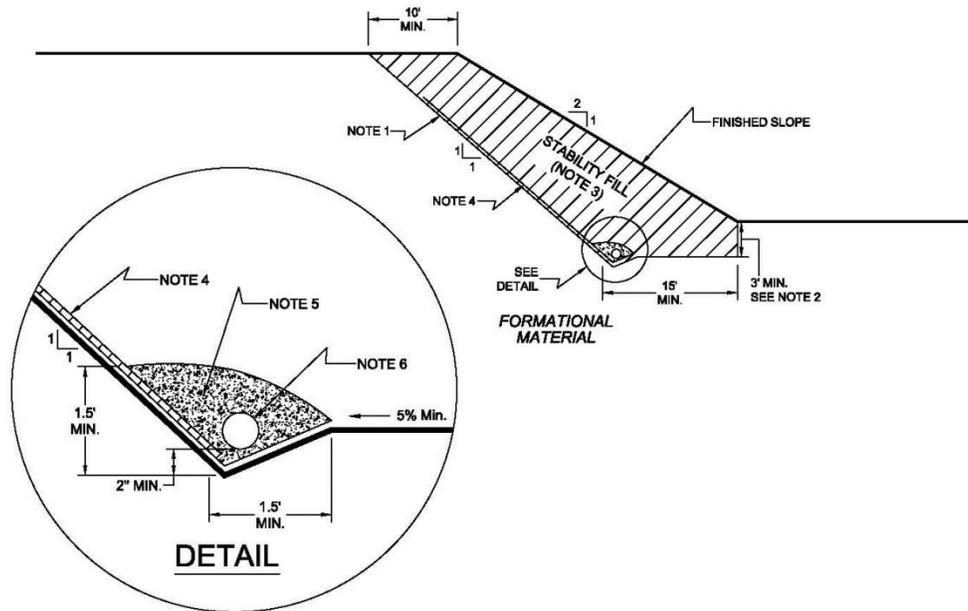
## TYPICAL STABILITY FILL DETAIL

### NOTES:

- 1.....EXCAVATE BACKCUT AT 1:1 INCLINATION (UNLESS OTHERWISE NOTED).
- 2.....BASE OF STABILITY FILL TO BE 3 FEET INTO FORMATIONAL MATERIAL, SLOPING A MINIMUM 5% INTO SLOPE.
- 3.....STABILITY FILL TO BE COMPOSED OF PROPERLY COMPACTED GRANULAR SOIL.
- 4.....CHIMNEY DRAINS TO BE APPROVED PREFABRICATED CHIMNEY DRAIN PANELS (MIRADRAIN G200N OR EQUIVALENT) SPACED APPROXIMATELY 20 FEET CENTER TO CENTER AND 4 FEET WIDE. CLOSER SPACING MAY BE REQUIRED IF SEEPAGE IS ENCOUNTERED.
- 5.....FILTER MATERIAL TO BE 3/4-INCH, OPEN-GRADED CRUSHED ROCK ENCLOSED IN APPROVED FILTER FABRIC (MIRAFI 140NC).
- 6.....COLLECTOR PIPE TO BE 4-INCH MINIMUM DIAMETER, PERFORATED, THICK-WALLED PVC SCHEDULE 40 OR EQUIVALENT, AND SLOPED TO DRAIN AT 1 PERCENT MINIMUM TO APPROVED OUTLET.

7.2 Slope drains within stability fill keyways should use 4-inch-diameter (or larger) pipes.

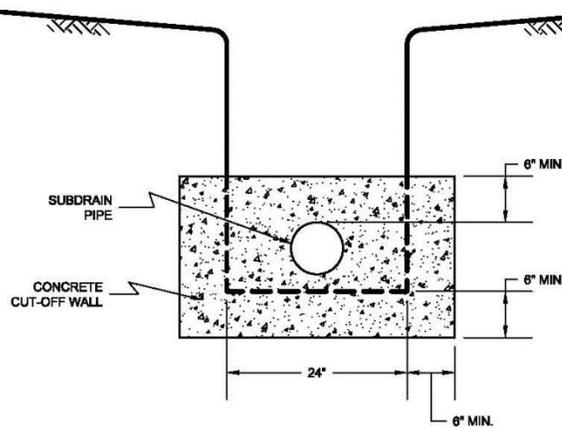
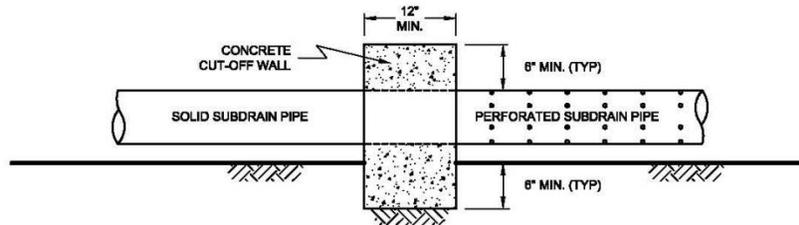
TYPICAL CUT OFF WALL DETAIL

FRONT VIEW

SIDE VIEW

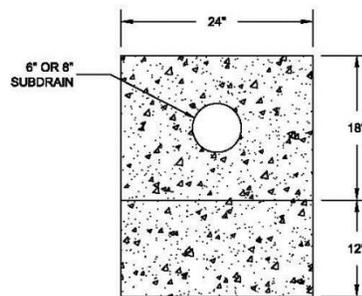
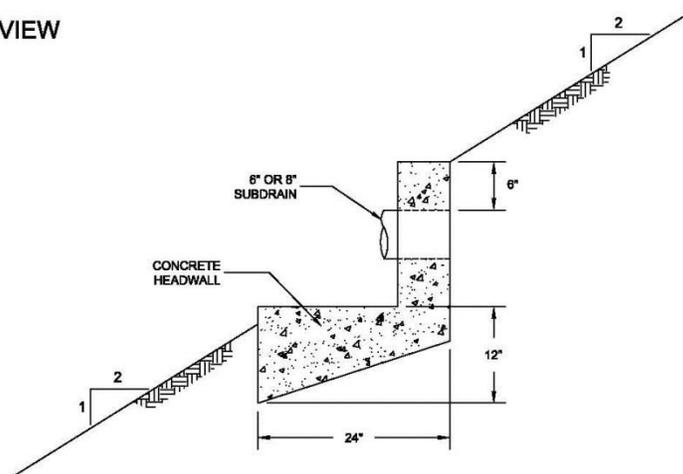
## TYPICAL HEADWALL DETAIL

### FRONT VIEW

### SIDE VIEW

NOTE: HEADWALL SHOULD OUTLET AT TOE OF FILL SLOPE  
OR INTO CONTROLLED SURFACE DRAINAGE

7.6 Subdrains that discharge into a natural drainage course or open space area should be provided with a permanent headwall structure.
