**GEOTECHNICAL/SEISMIC HAZARD
STUDY FOR THE SAFETY ELEMENT
OF THE SANTEE GENERAL PLAN**

**CITY OF SANTEE
COUNTY OF SAN DIEGO,
CALIFORNIA**

**OCTOBER 31, 2002
FINAL REPORT**

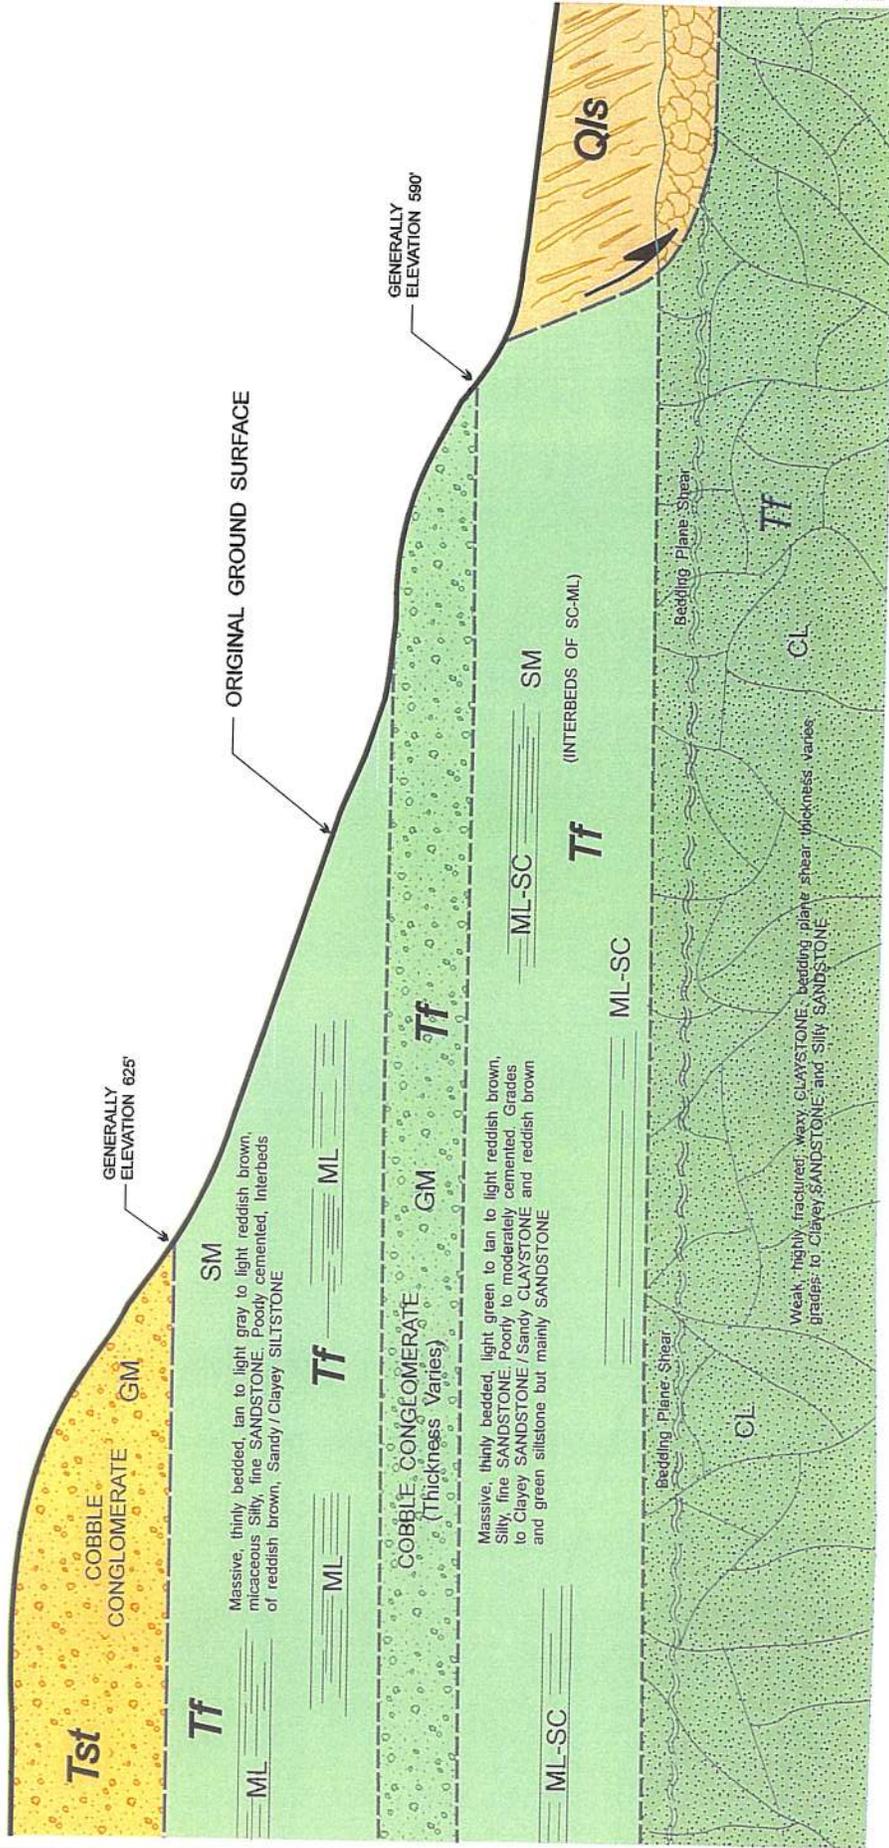
GEOCON
 INCORPORATED
 GEOTECHNICAL CONSULTANTS
 6960 FLANDERS DRIVE - SAN DIEGO, CALIFORNIA 92121-2974
 PHONE 858 558-6900 - FAX 858 558-6159
 PROJECT NO. 06828 - 32 - 01
 FIGURE 4
 DATE 10 - 31 - 2002

CHARACTERISTIC GEOLOGY OF NORTHERN SANTEE AREA

NO SCALE, CONCEPTUAL ONLY

Formational units include the Eocene-age Stadium Conglomerate and Friars Formation, and Cretaceous granitic rock associated with the Peninsular Ranges. Both the Stadium Conglomerate and Friars Formation are sedimentary units. The clay portions of the Friars Formation are typically weak and prone to landsliding, whereas the overlying Stadium Conglomerate, although itself resistant to instability, may be "carried" with landslides in the underlying Friars Formation. Each of the surficial soil types and geologic units encountered is described below in order of increasing age. A discussion of the relationships between the units is presented in the Geologic Structure section of this report. A generalized depiction of the geology characteristic of the northern portion of the city is presented on Figure 4.

As seen in the northern, undeveloped area of Santee (see Figure 4), the Friars Formation comprises a relatively continuous sequence of characteristic subunits consisting of thinly bedded sandstone/siltstone, underlain by relatively thin lenses of gravel/cobble conglomerate, which are in turn underlain by massive sandstone. A generally weak, fractured, waxy claystone unit containing abundant bedding plane shear zones underlies this sequence. It is likely the inherently weak nature of this basal claystone unit in combination with the occurrence of bedding plane shear zones has resulted in the landsliding and landslide-prone hillsides.

A landslide is defined as any mass movement of earth occurring below the limits of the soil mantle caused by shear failure along one or several surfaces (see Figure 4, Characteristic Geology of the Northern Santee Area). Ancient landslides have been dated by radiocarbon methods as being 8 to 30 thousand years old in the southern California area by Stout (1969) and others. They are believed to have occurred primarily as a response of weak claystones to intense rainfall and high water table conditions in slopes during late Pleistocene and early Holocene time.
